EPSON PRODUCT SUPPORT BULLETIN

Date:	2/2/2004	Originator:	JD
PSB #:	PSB.2004.02.008	Authorization:	Kas/DS
Reference:	TE03-379 Rev. A	Total Pages:	2
Product(s):	Perfection 1670/2400/3170/3200 Series Scanners & Stylus CX3200/5200/5400/6400/Stylus Photo RX500 All-in-One Products		
Subject:	Smart Panel Compatibility on Mac OS 10.3

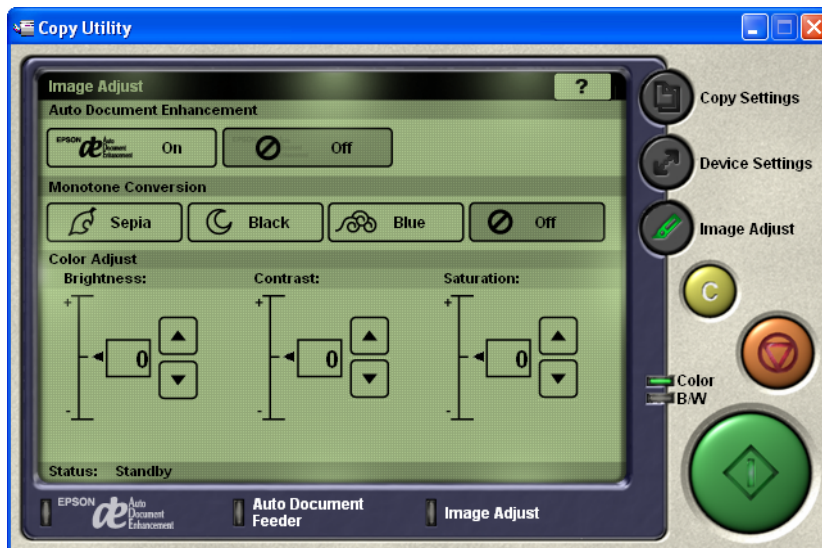
This is because when printing to non-EPSON printers with the Copy utility, the Automatic Document Enhancement feature is turned off by default.

Click on the “Image Adjust” button. You will notice the Auto Document Enhancement OFF button is selected (highlighted in dark gray).

To remove the background, you must enable Automatic Document Enhancement. To turn on this feature, launch the Copy applet by double-clicking on its icon. Select Epson TWAIN 5 at the following window and click "OK".

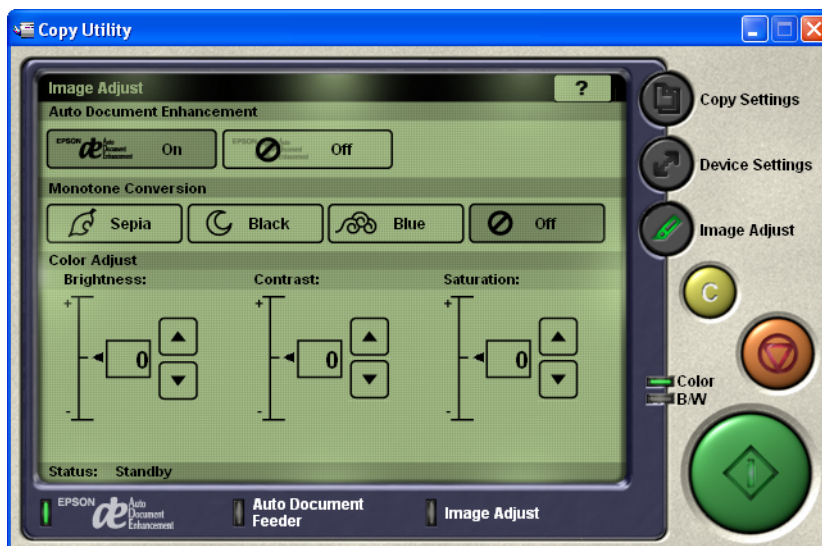
Click the ON button. You will now notice that this button is selected (highlighted in dark gray).

Now click on the large green Copy button, your image will be scanned and printed. The copy of your document should look very close to the original with no background colors added.

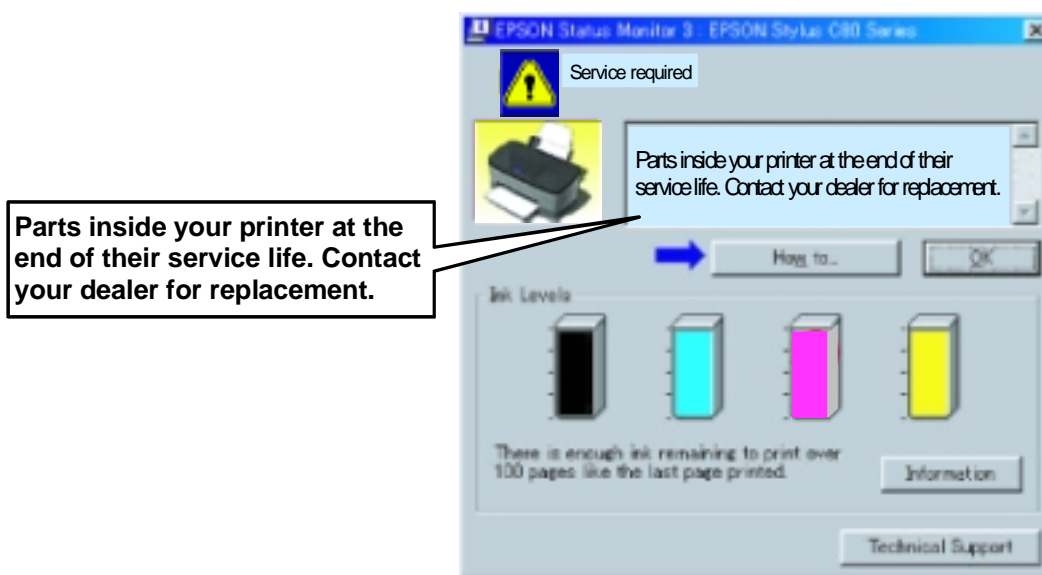
This bulletin was created to inform you of the maintenance request message. When the following message appears, the waste ink pads inside the printer are full and need to be replaced. You should take the unit to your local servicer to do the replacement.

For information on finding your nearest authorized servicer contact Epson at 1-800-922-8911 or go to WWW.EPSON.COM.
